**WASTE MANAGEMENT DIVISION
RCRA ENFORCEMENT OFFICE
RCRA COMPLIANCE EVALUATION INSPECTION REPORT**

Purpose:	RCRA Compliance Evaluation Inspection
Facility Location:	US Coast Guard Base Support Unit San Pedro 1001 S. Seaside Ave., San Pedro, CA 90731
U.S. EPA ID Number:	CA9690308730
Date of Investigation:	February 9, 2011
U. S. EPA Investigator:	Michael Prescott, EPA Contractor 5221 Burke Dr., Alexandria, VA 22309 (703) 373-3811
CUPA Representative:	Ruben Garcia, Hazardous Materials Specialist Los Angeles County Fire Dept 24330 S. Narbonne Ave., Lomita, CA 90717 (310) 534-6278
Facility Representatives:	Kathryn Gregory, Environmental Protection Specialist (Primary facility contact) (310) 521-6020 Courtney Jensen, MST3 Len Ringel, Asst. Engineering Officer
Report Prepared By:	Michael Prescott Robin Holloway, US EPA Region 09
Report Date:	April 15, 2011

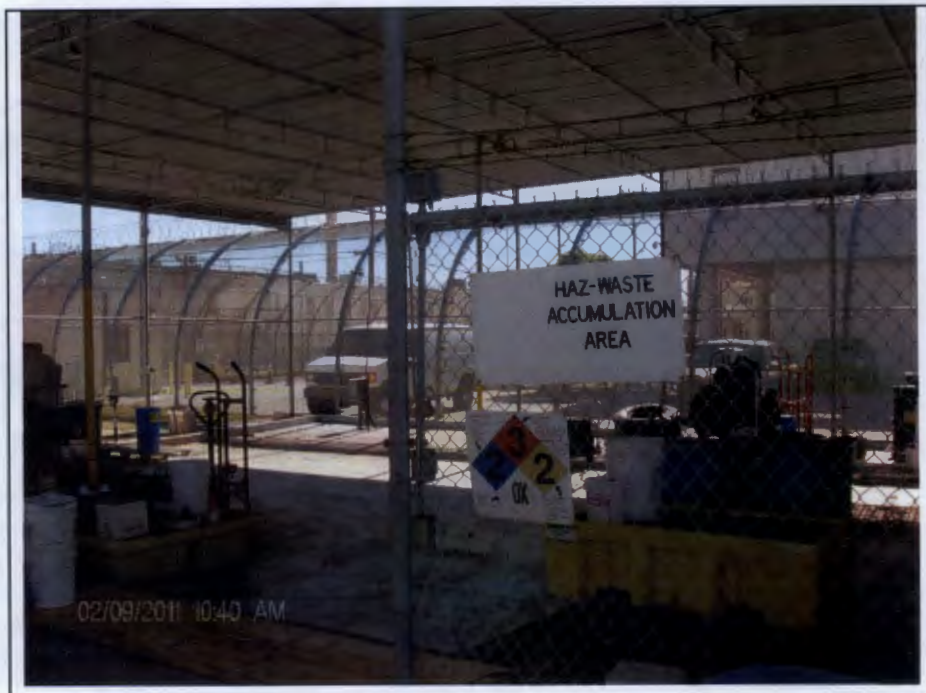
PHOTO #: 1

The 90-day hazardous waste CAA was a covered and fenced -in area located next to Bldg. 10 (see Photo #1). A waste pickup had occurred the day before the inspection. Some containers of RCRA and non-RCRA, California only hazardous wastes had not been picked up, according to Ms. Gregory, because they were not in the paperwork for the pickup. They were properly labeled, closed, and dated (see Photos #3 and #4). There was also a container of broken spent lamps in the CAA that was labeled universal wastes but did not have a hazardous waste label (see Photo #2).

COMMENTS: View of entrance to the hazardous waste Central Accumulation Area (CAA).

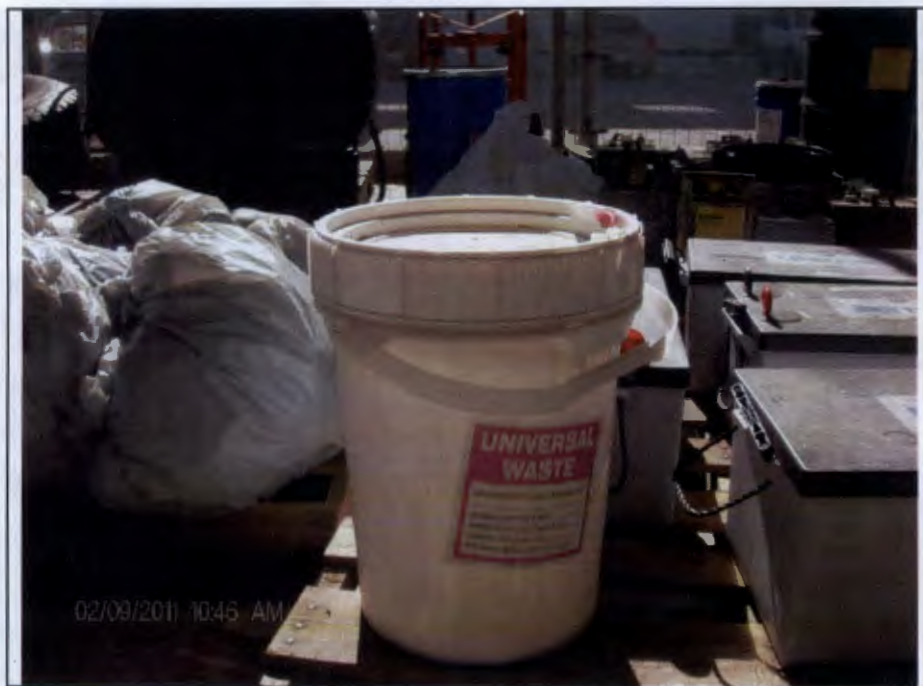
PHOTO #: 2

Field Inspection Observations: A container of broken spent lamps in the CAA was labeled as universal waste but did not have a hazardous waste label. A locker in the CAA containing spill control equipment also contained hazardous wastes but was not labeled. A container of amalgam traps at the dental clinic SAA in the Medical Clinic was not labeled.

COMMENTS: Broken spent fluorescent lamps in a container labeled universal wastes.

Action Taken by the Facility: In a letter dated 7 April 2011, USCG San Pedro stated that the container of broken lamps had been labeled as hazardous waste.

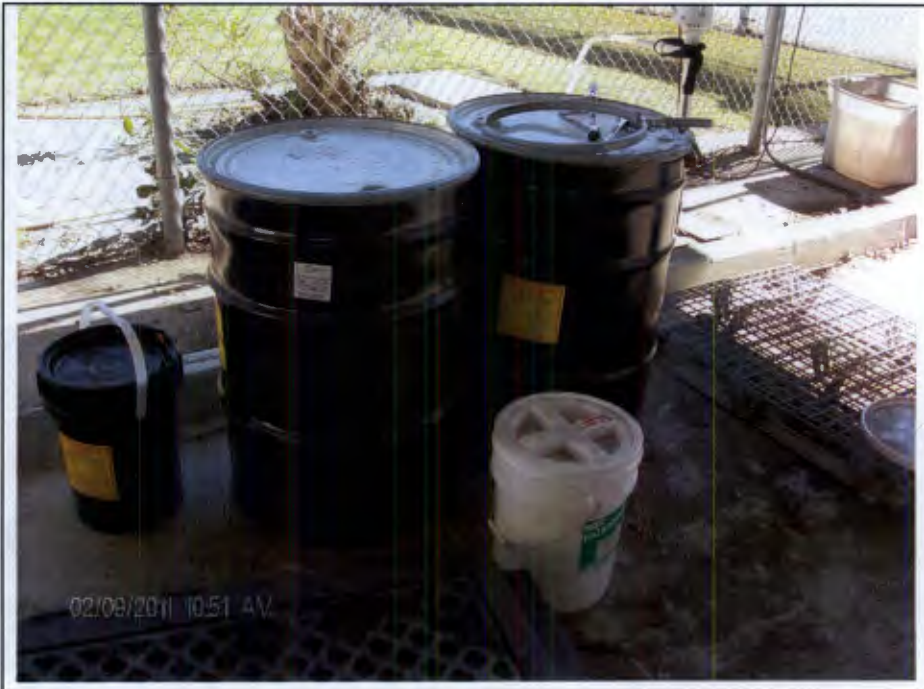
PHOTO #: 3

COMMENTS: Containers of RCRA and CA hazardous waste and nonhazardous waste.

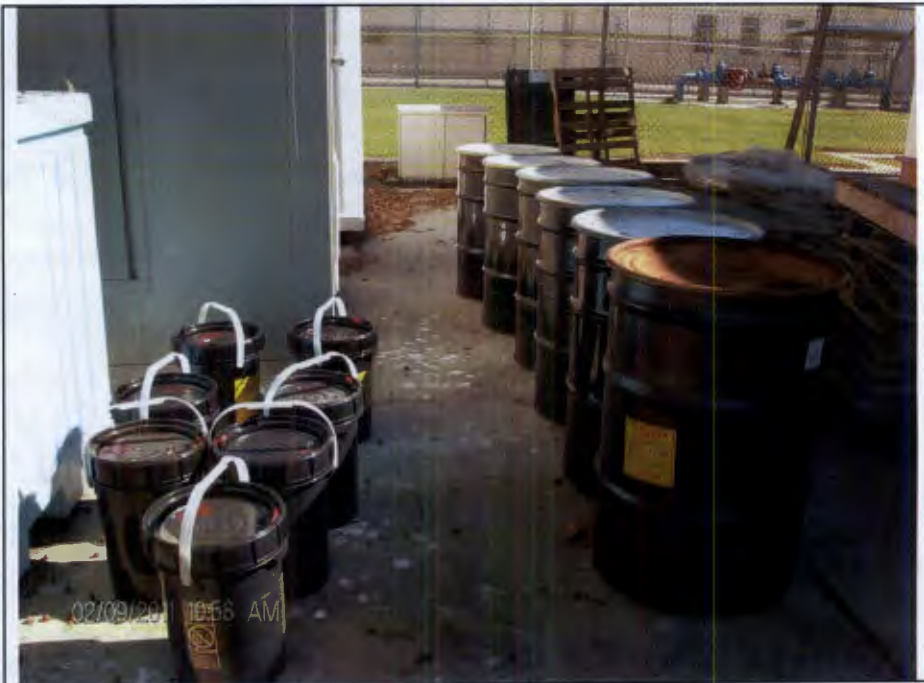
PHOTO #: 4

COMMENTS: Two drums of RCRA hazardous waste and the rest of the drums and containers are CA hazardous wastes.

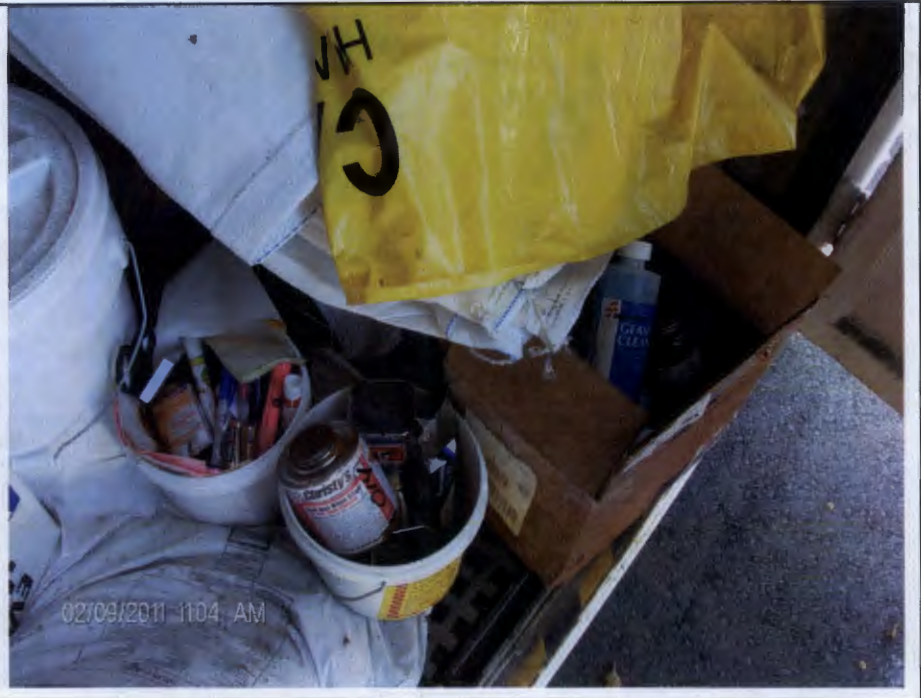
PHOTO #: 5

The CAA was equipped with an eye wash and shower, fire extinguisher, telephone, and an alarm that sounded at the CAA. Spill control and cleanup equipment was located in a locker at the CAA. Hazardous materials awaiting waste determinations were in the locker as well (see Photo #5).

On March 16, 2011, EPA sent USCG San Pedro a letter requesting additional information. According to their response, dated 7 April 2011 (Attachment 2), some of the materials in the locker are hazardous waste.

COMMENTS: Hazardous materials awaiting waste determinations in the spill equipment locker.

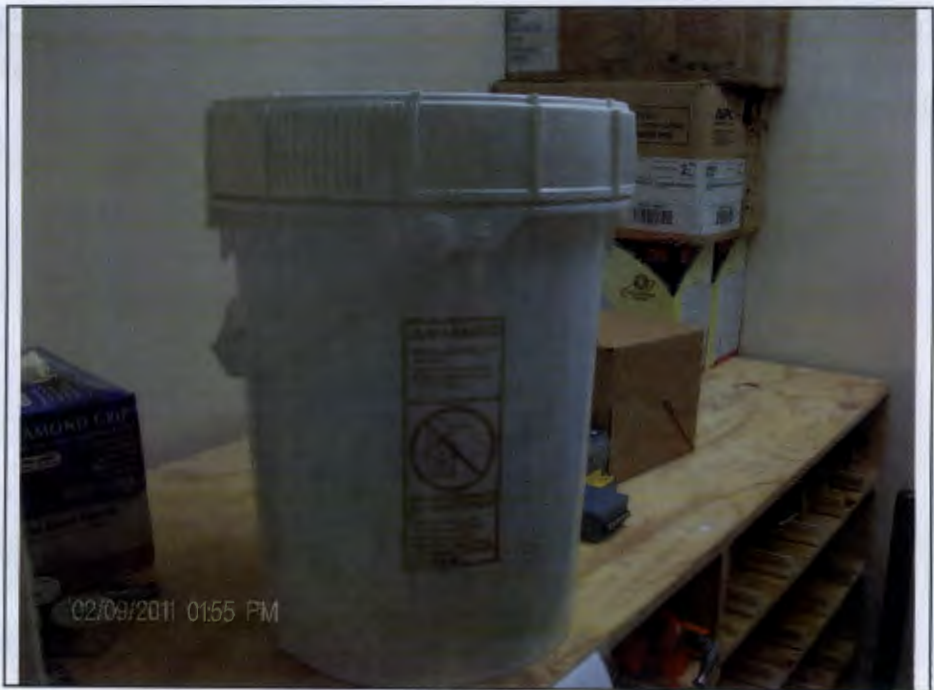
PHOTO #: 6

Ms. Gregory reported the X-ray processors at this building were all digital and did not use chemicals. There was a small lab at the clinic which did not have any hazardous waste. In the dental clinic, amalgam wastes were collected in two containers: one was properly labeled, but one container of waste amalgam traps was not labeled (see Photo #6). According to USCG San Pedro's April 7, 2011 letter, amalgam traps are managed as hazardous waste.

COMMENTS: Container of amalgam traps with no hazardous waste label.

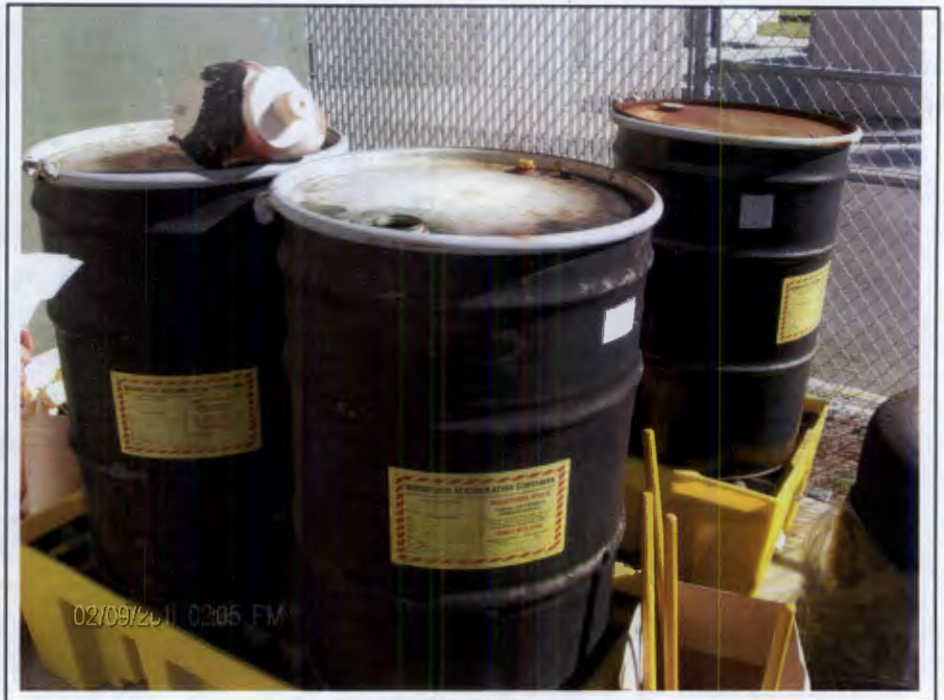
According to Ms. Gregory, the unit at this location conducted minor boat maintenance, but was deployed at the time of the inspection. There were drums of used oil and filters outside the building and one of the drums was open (see Photo #7).

COMMENTS: Drums of waste oil and filters regulated as CA hazardous waste (note one of the drums was open).

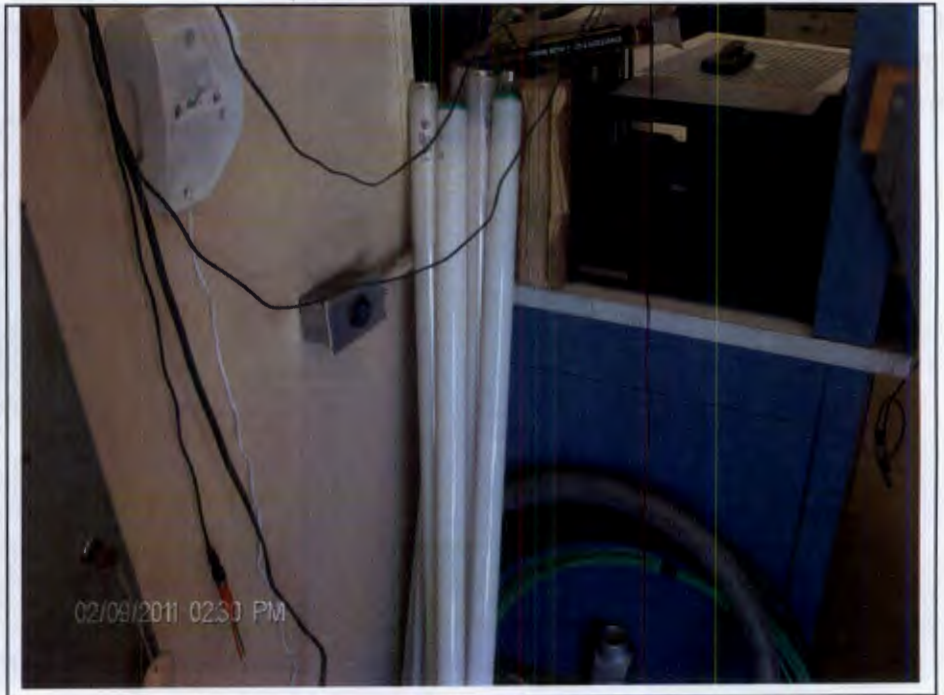
There were several small facilities maintenance shops including the HVAC, Carpentry, Electrical, and DC Shops, but no hazardous wastes were observed in these shops. However, in the Electrical Shop, a few loose spent lamps that were awaiting transport to the CAA (see Photo #8) were leaning against a wall. In the DC Shop, there was a trench drain marked "Drains to

Field Inspection Observations: In the Electrical Shop, a few loose spent lamps that were awaiting transport to the CAA (see Photo #8) were leaning against a wall.

COMMENTS: Loose spent fluorescent lamps awaiting transport to the CAA.

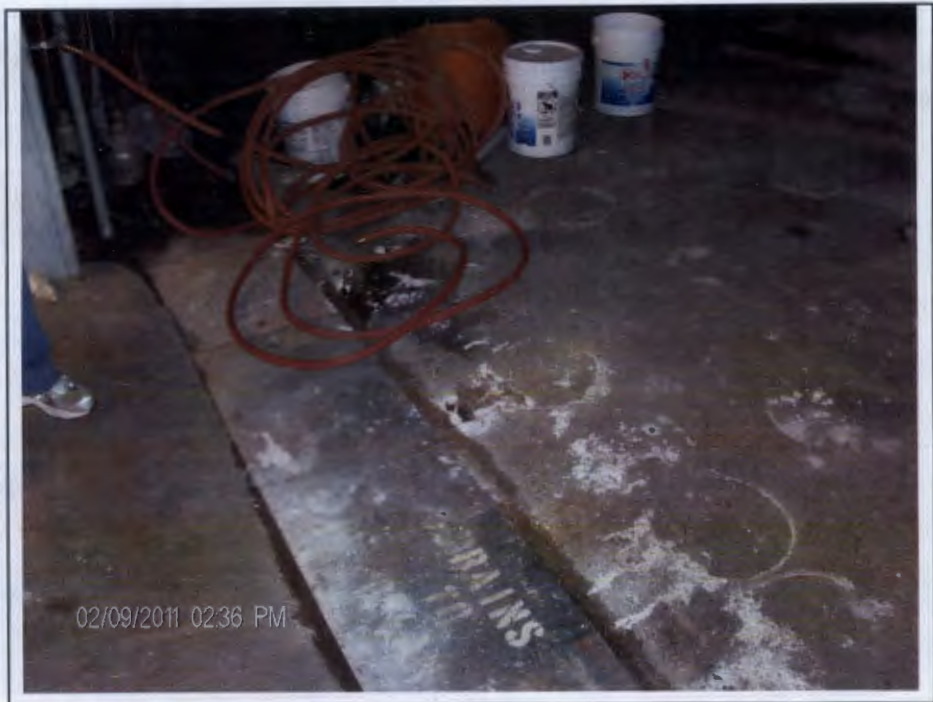
PHOTO #: 9

Ocean” with paint stains on it (see Photo #9). Next to it were paint and mop buckets and a hose with signs of water over the drain (see Photo #10). Ms. Gregory reported that the area had been enclosed about eight months ago and she did not know if paint or mop buckets were rinsed or dumped here. The inspector explained that this drain appeared to be an illicit connection and should not be connected to a storm sewer.

COMMENTS: Paint stains and paint and mop buckets on storm drain.

In USCG San Pedro’s April 7, 2011 letter, they indicated that wash water and waste paint are never put down the storm drain.

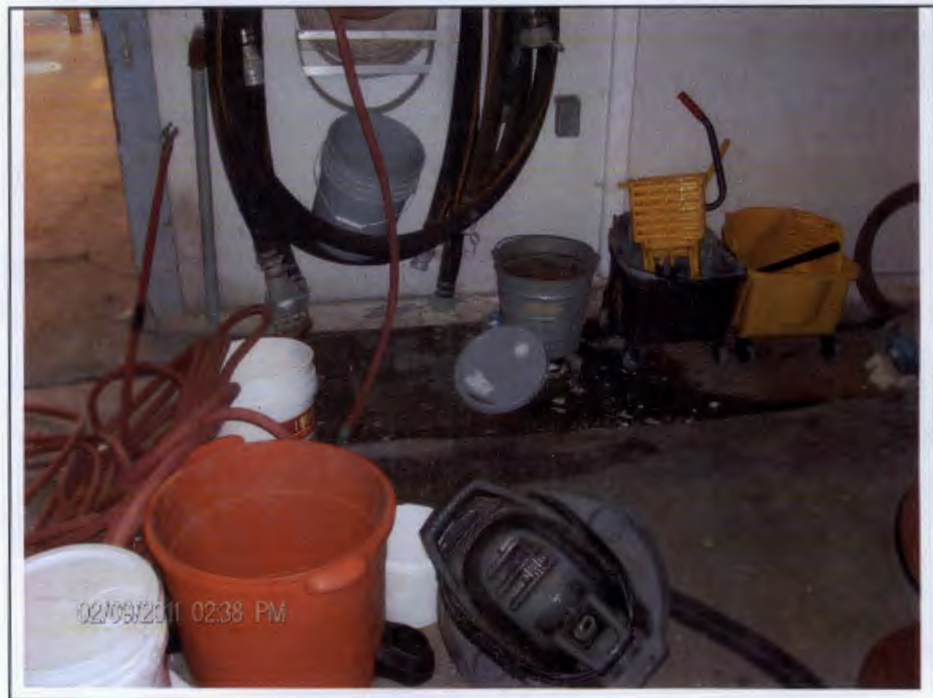
PHOTO #: 10

COMMENTS: Paint and mop buckets next to a hose over a storm drain.

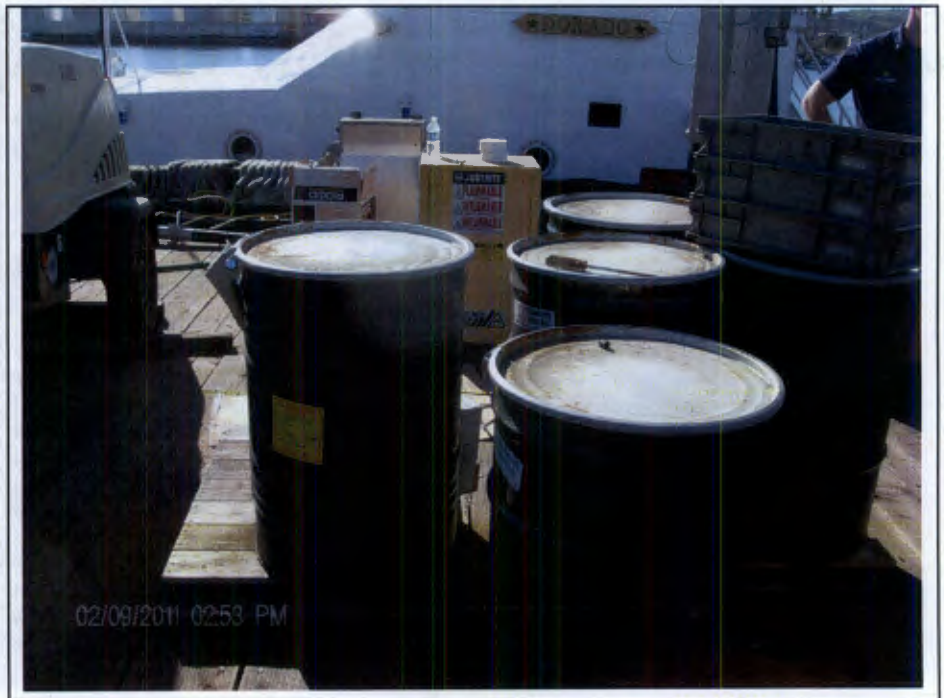
PHOTO #: 11

Next to the water at the Industrial Wharf, I observed a contractor operation that Ms. Gregory explained was for recoating a boat. Brian Joyce, Safety and Environmental Coordinator for the contractor, Nautical Engineering, explained that they were removing coatings on the boat and accumulating the waste chips in a drum that was closed, labeled, and dated (see Photo #11). After the coating was removed, they would then apply a zinc primer to replace the coating.

COMMENTS: Drum of RCRA hazardous waste paint chips from boat recoating project by a contractor.
